## **Degradation and Rebuilding of Friction Stir Welding Tools**

PhD dissertation

Institute of Physical Metallurgy, Metal-forming and Nanotechnology

University of Miskolc, Miskolc, Hungary

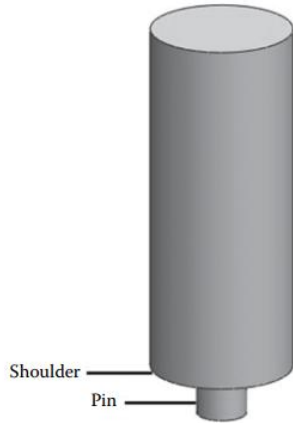
the resulting weld integrity. An FSW tool consists of two main components: a shoulder and a pin, as shown in Figure 2 [8]. The shoulder contacts the workpiece surface, producing the majority of frictional heat while forging and confining the softened material, whereas the pin penetrates the joint line to mix and transport the plasticised metal [9].

Figure 2. The FSW tool consists of a pin and a shoulder.

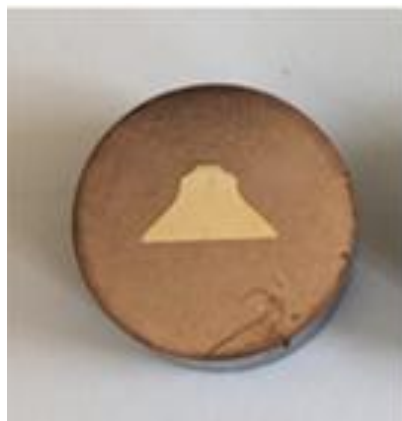
Following surface characterisation, the probe was longitudinally sectioned to expose its internal microstructure along its central axis (see Figure 13). The sectioned sample was hot-mounted and prepared using standard metallographic grinding and polishing procedures to achieve a mirror-like surface finish suitable for microstructural examination. The polished sample was then chemically etched using aqua regia, prepared from 60 mL hydrochloric acid (HCl) and 20 mL nitric acid (HNO<sub>3</sub>), applied for 45 seconds to reveal the grain structure and microstructural features of the MP159 alloy.

Figure 13. Sectioned MP159 probe sample after metallographic preparation (grinding and polishing), showing the exposed longitudinal cross-section prior to etching.

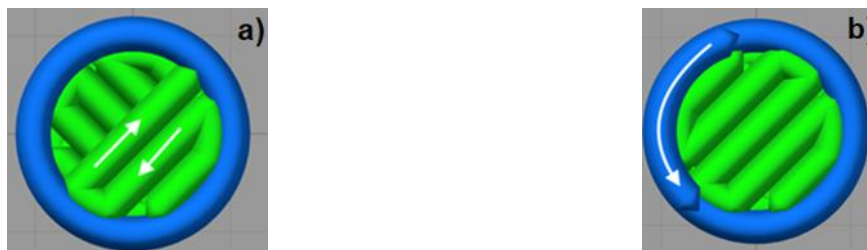
Figure 25. The Deposition patterns are bidirectional with filler: a) inner deposition with 90° rotation for each layer, b) the outer filler.

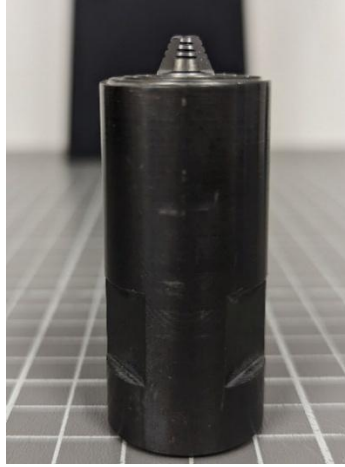
Figure 44. H13 steel FSW tool.

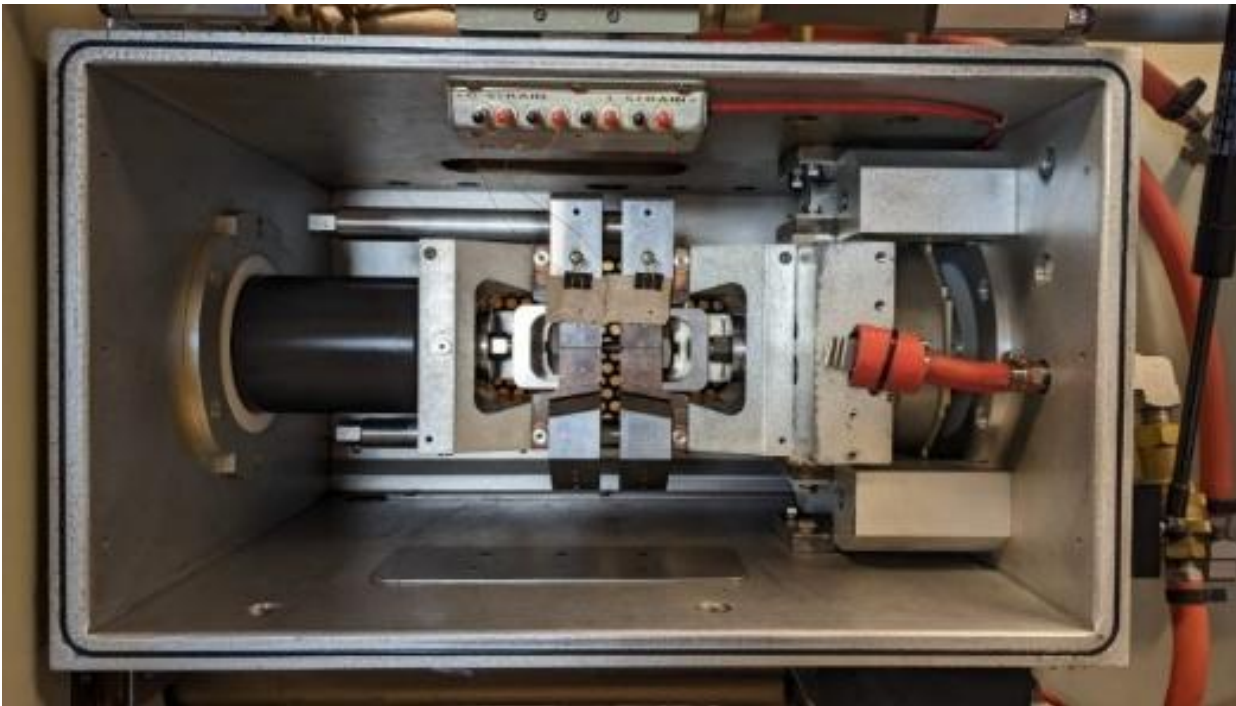
Figure 45. Testing chamber of the Gleeble physical simulator 300 machine.

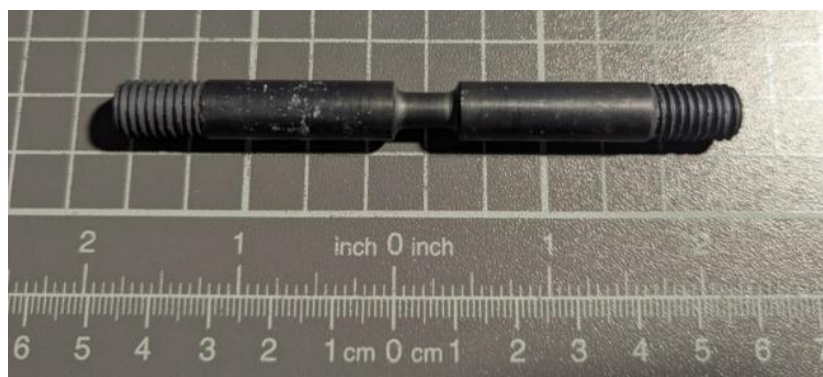
Figure 48. Sample of the thermal simulation.

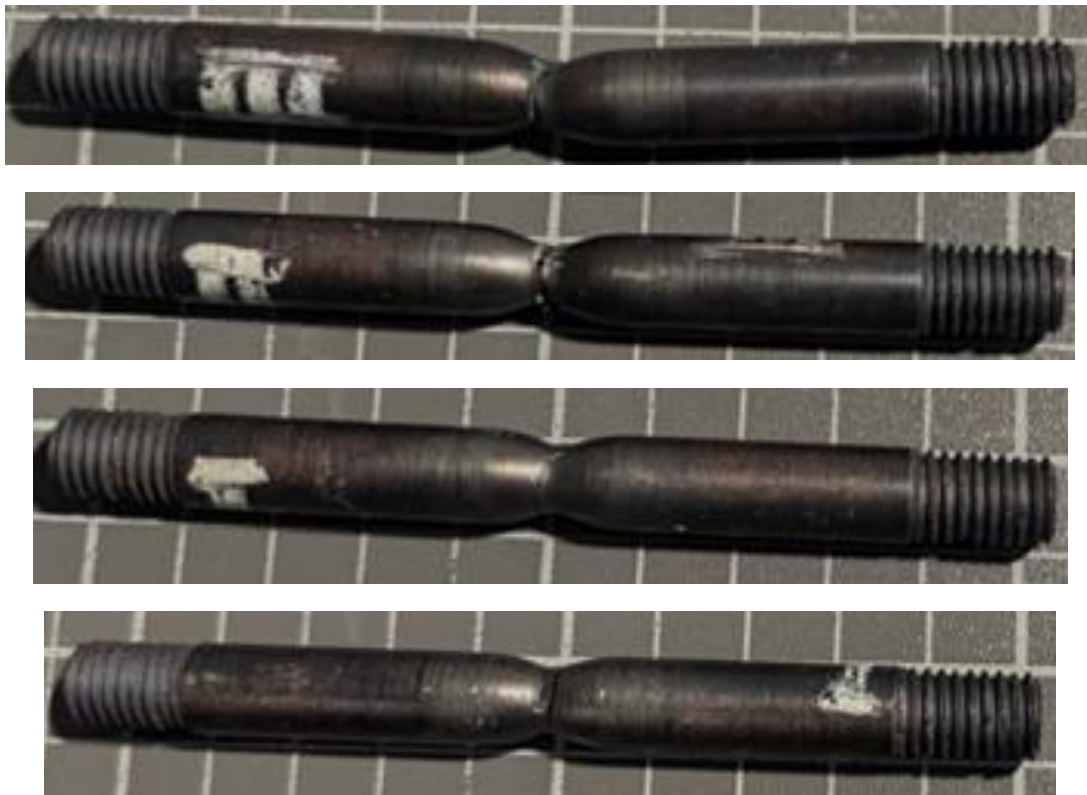
Figure 50. The mechanically simulated samples, tested at four different strain rates after failure in the Gleeble simulator: a) 2.54 s<sup>-1</sup>, b) 25.4 s<sup>-1</sup>, c) 254 s<sup>-1</sup>, d) 1016 s<sup>-1</sup>.
